Transurban's Conspicuity Markings: Improving Vehicle Visibility for Safer Roads

Key Safety Focus: Conspicuity Markings

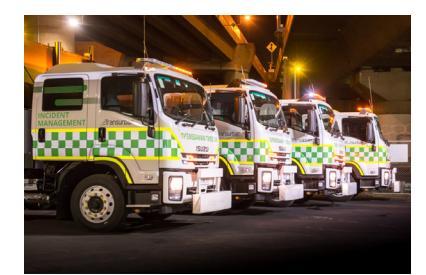
This saw Transurban introduce conspicuity markings on its fleet of incident response vehicles. Conspicuity markings are retroreflective markers that highlight the contoured shape of a vehicle from various angles. They play an important role in increasing visibility to prevent crashes on the road, particularly during low-light conditions or when vehicles are pulled over to the side of the road.

To maximise visibility, these guidelines require vehicles to have a white base colour, and full contour markings to clearly outline the rear, sides, and front of the vehicle. To ensure the vehicle outline can be clearly distinguished, the markings are also applied around the wheel hub and truck toolboxes/cabinets. Transurban's conspicuity markings include wide strips of reflective, fluorescent yellow tape that provide vivid retroreflectivity at wide angles, almost 90 degrees from perpendicular, to help improve visibility.

Transurban incident response vehicles also feature a white and green (or blue and yellow in Queensland) Battenberg pattern (alternating rectangles of colours) between two strips of conspicuity tape to increase vehicle visibility, distinguishing Transurban vehicles from other incident response operators on the road.

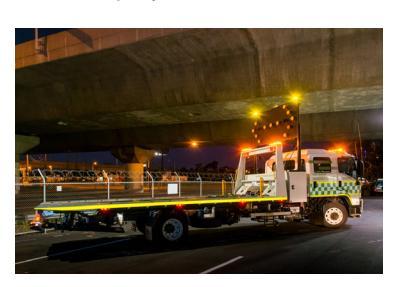
The distinctive yellow conspicuity tape and Battenberg pattern distinguish Transurban vehicles from other response teams or incident response vehicle operators, providing customers with the confidence that they are receiving the highest standard of service and safety when they see these vehicles. Customer feedback indicates they feel a sense of relief and safety when they see Transurban incident response teams arrive, and the increased visibility and recognisability of these vehicles from the conspicuity markings may play a role in this.
